WATER STORAGE TANKS CLEANING & DISINFECTION REPORT

11th November 2022

INTERNATIONAL INDIAN SCHOOL

International Indian School
Under Ground – RCC TANK
WATER TANK CLEANING & DISINFECTION

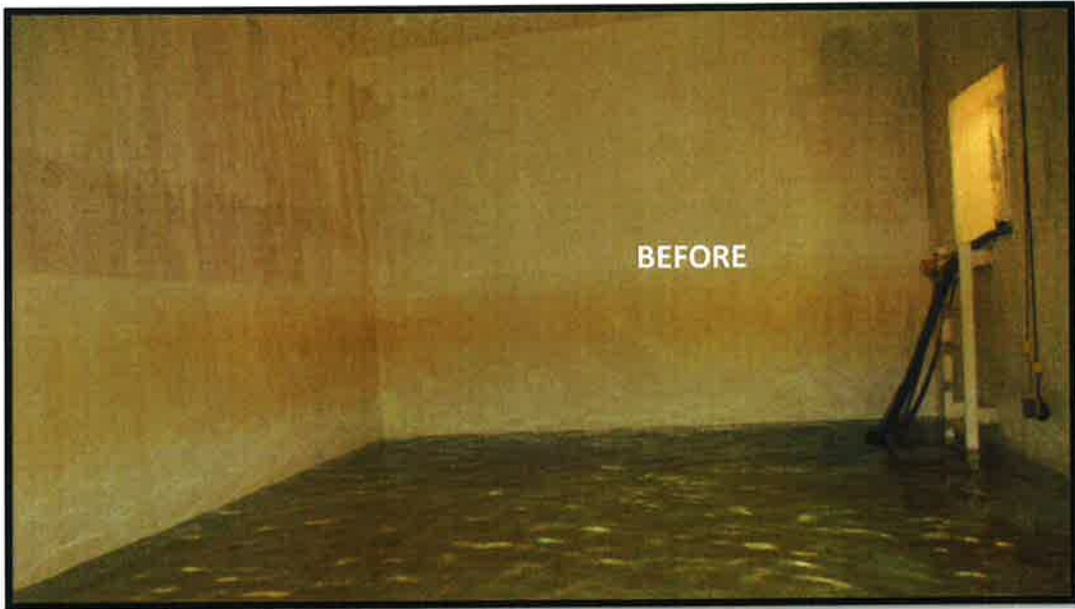
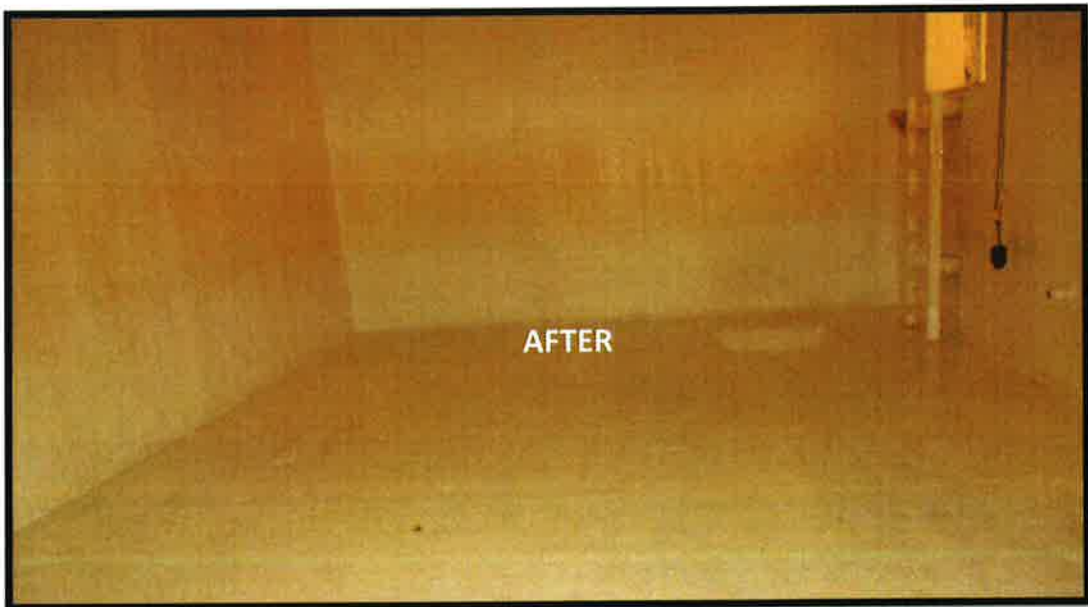
International Indian School
Under Ground - RCC TANK

WATER TANK CLEANING & DISINFECTION

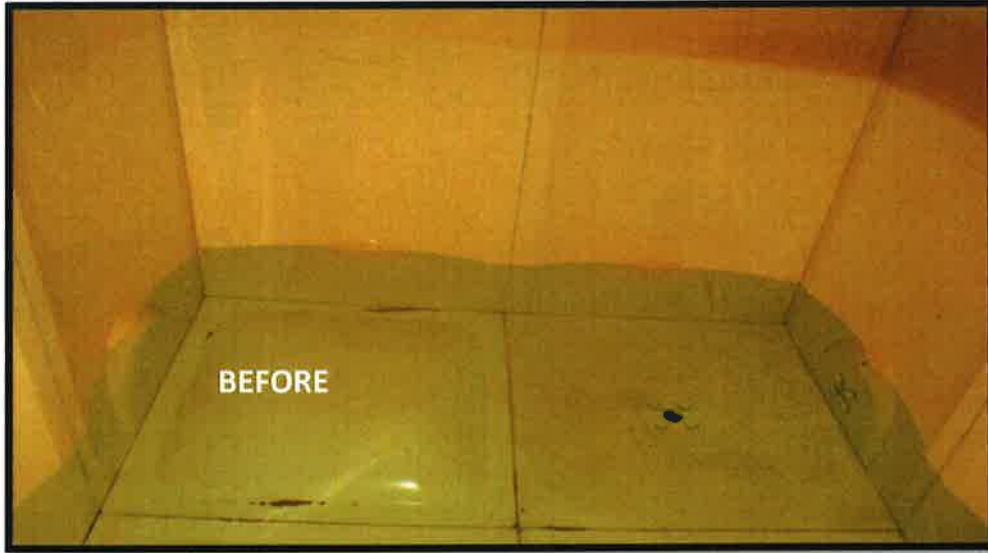
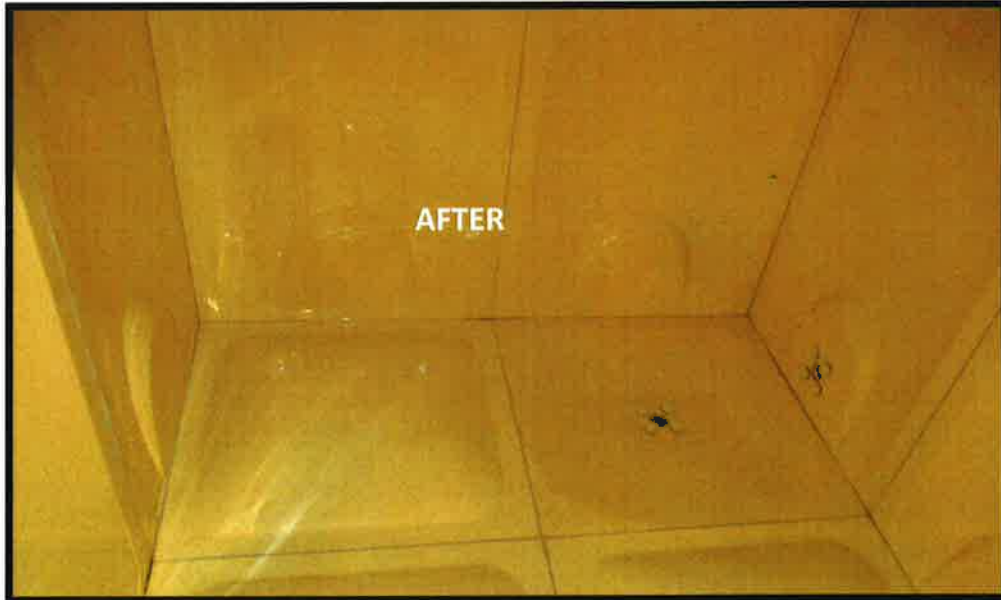
Roof Top Tank 1 - GRP

WATER TANK CLEANING & DISINFECTION

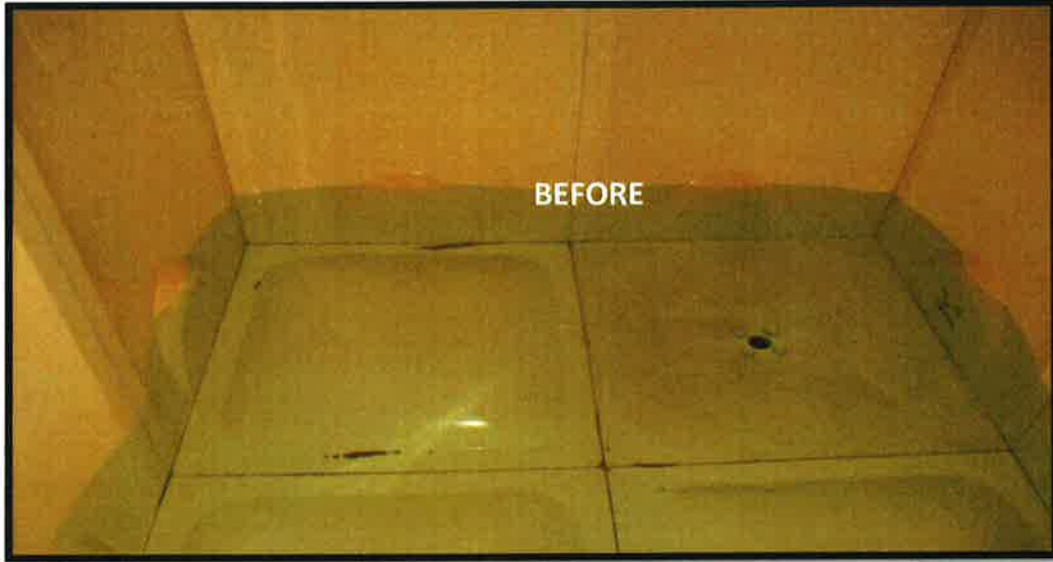
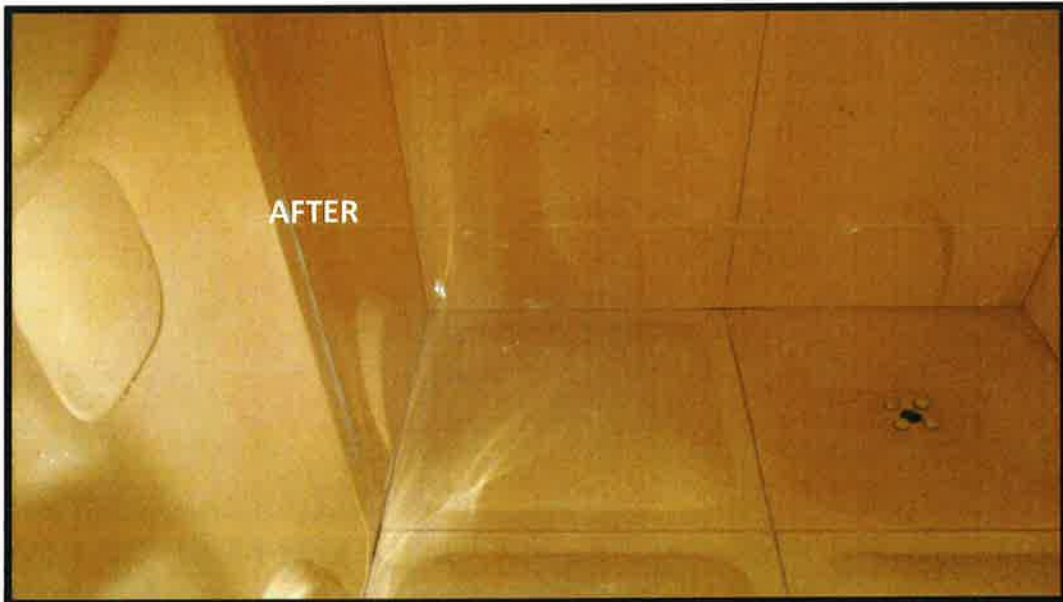
Roof Top Tank 1 - GRP

WATER TANK CLEANING & DISINFECTION

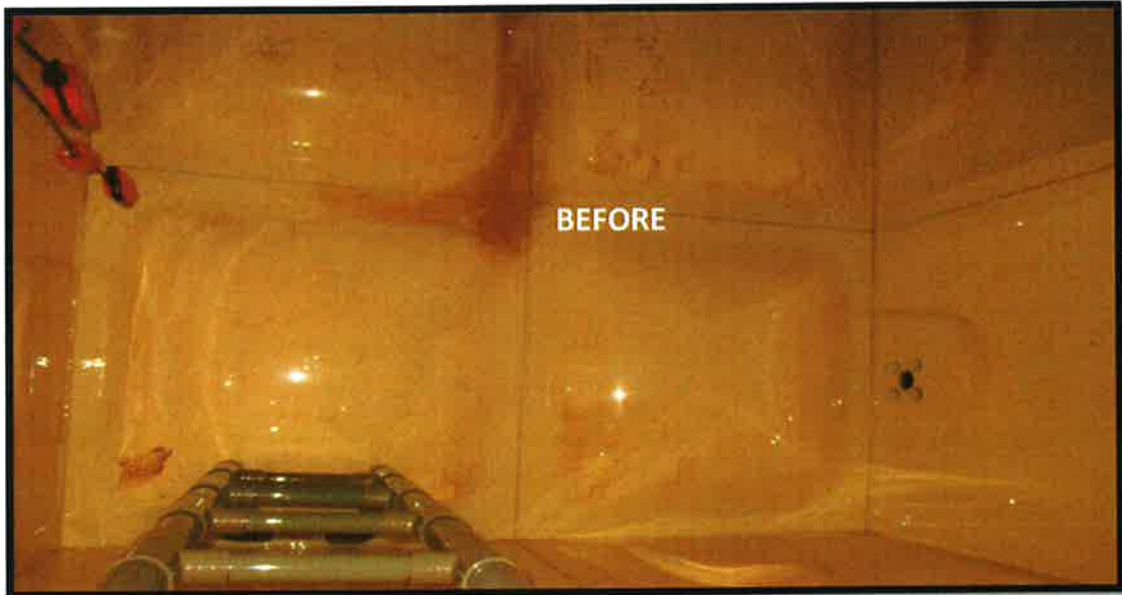
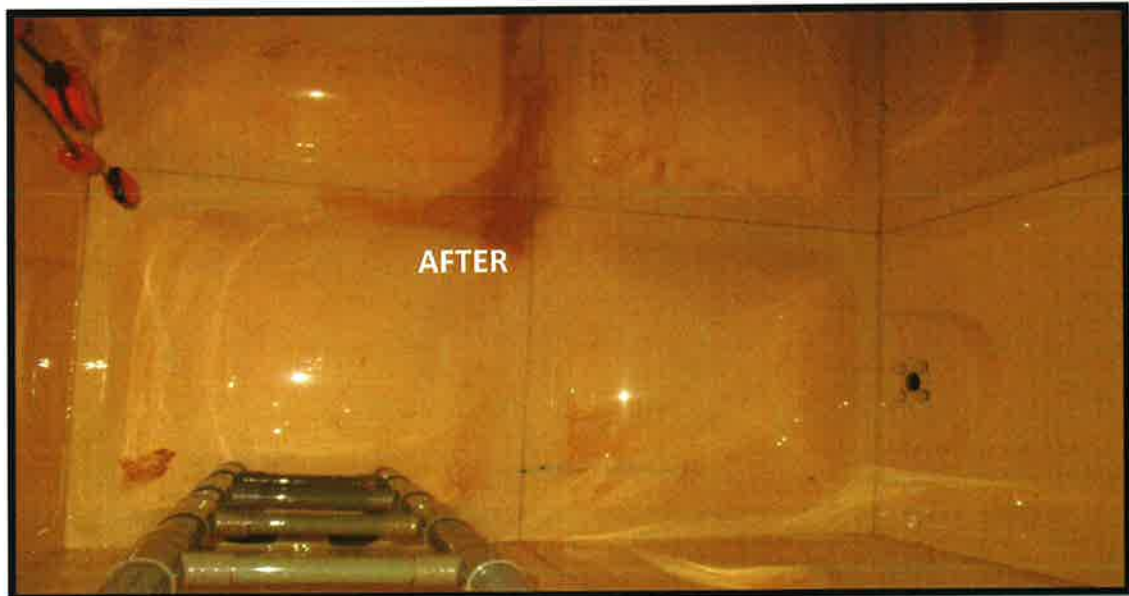
Roof Top Tank 2 - GRP

WATER TANK CLEANING & DISINFECTION

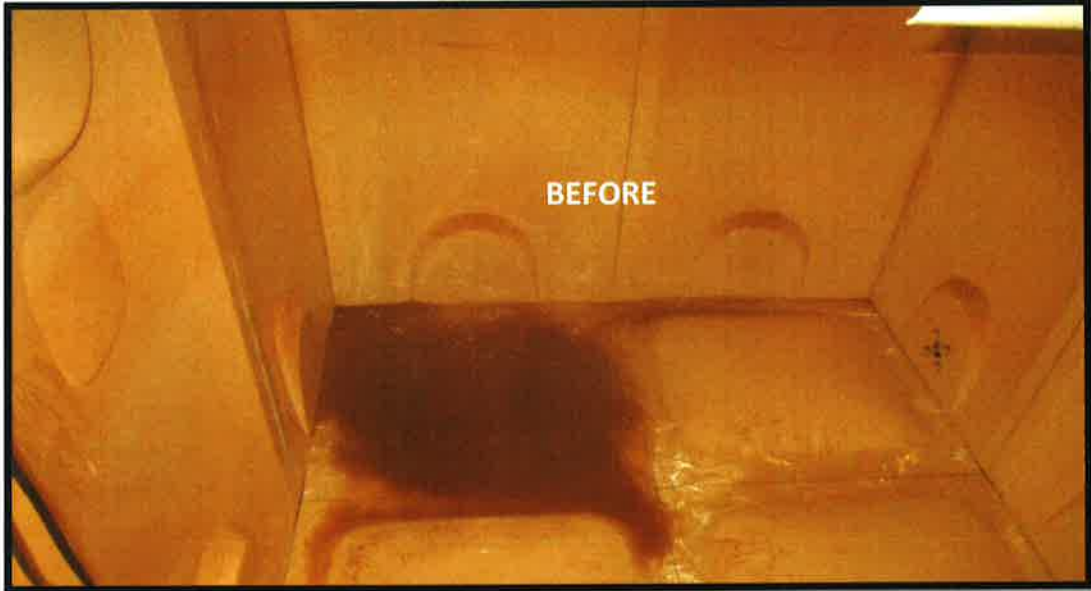
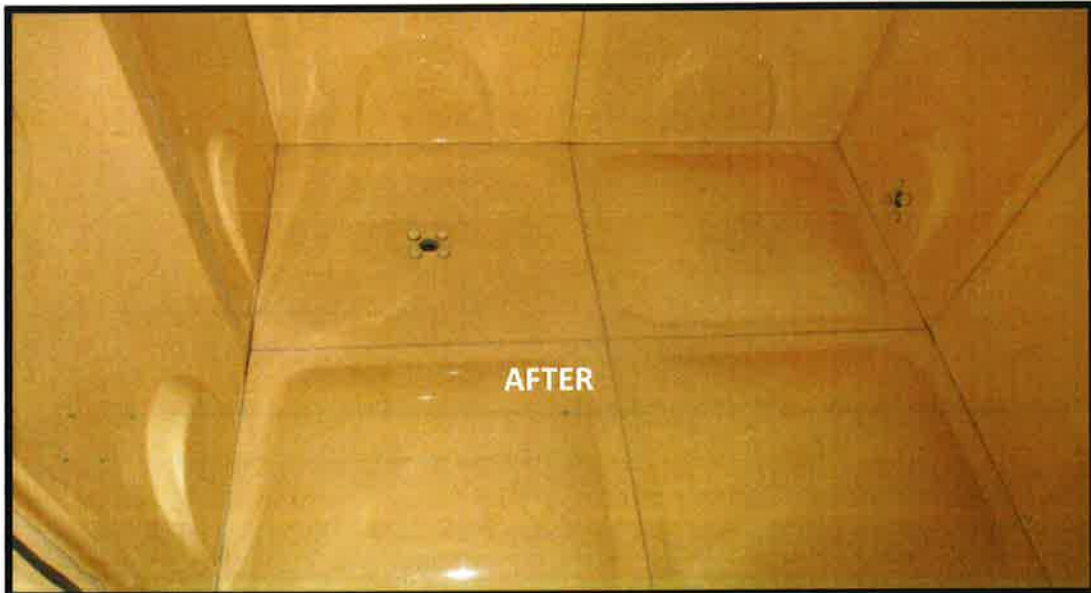
Roof Top Tank 2 - GRP

WATER TANK CLEANING & DISINFECTION

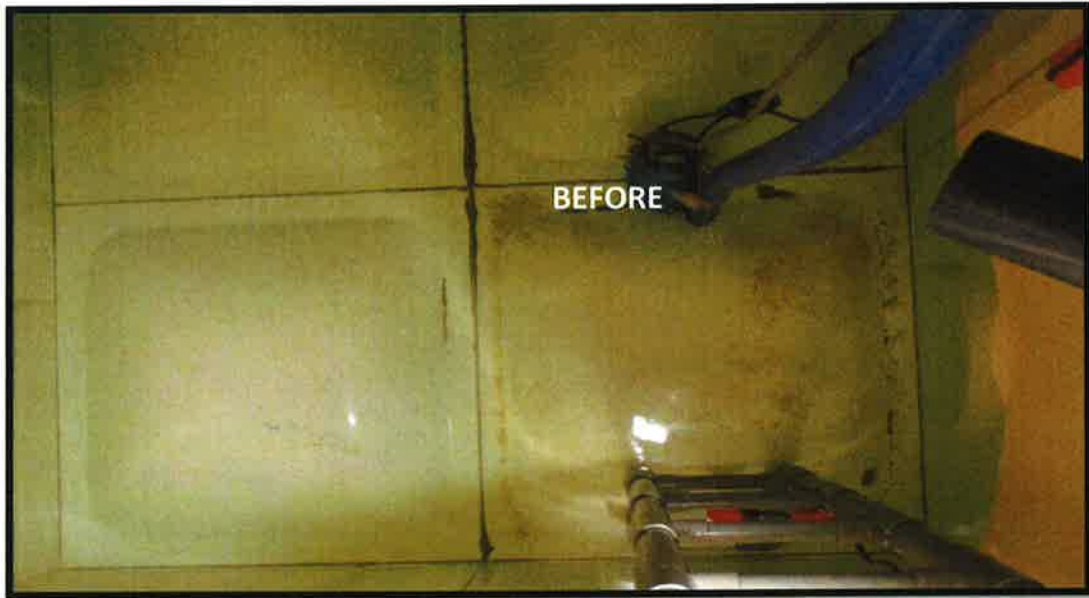
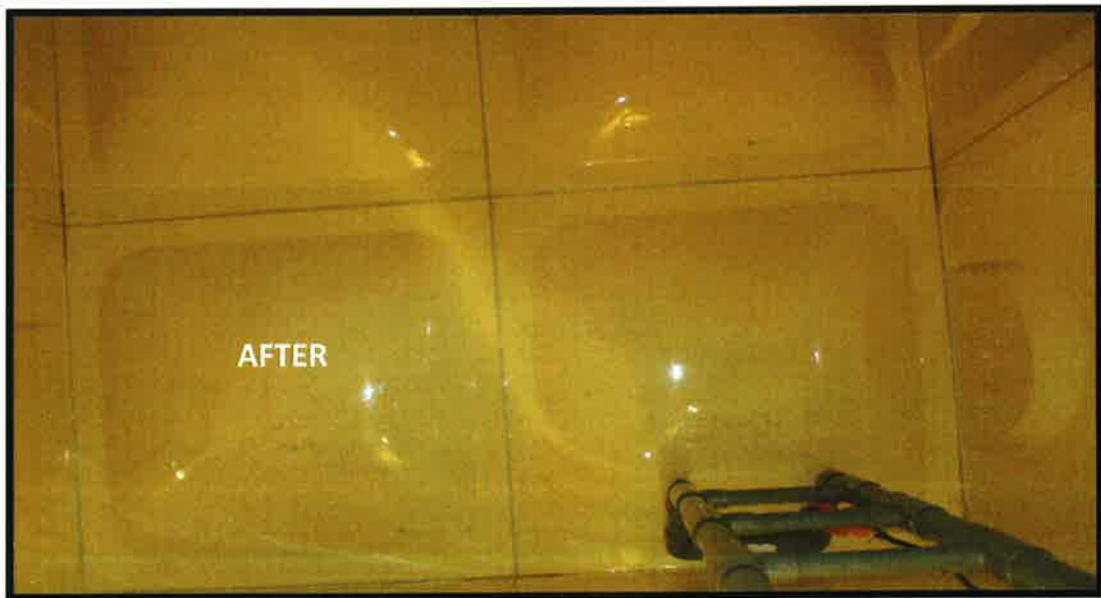
Roof Top Tank 3 - GRP

WATER TANK CLEANING & DISINFECTION

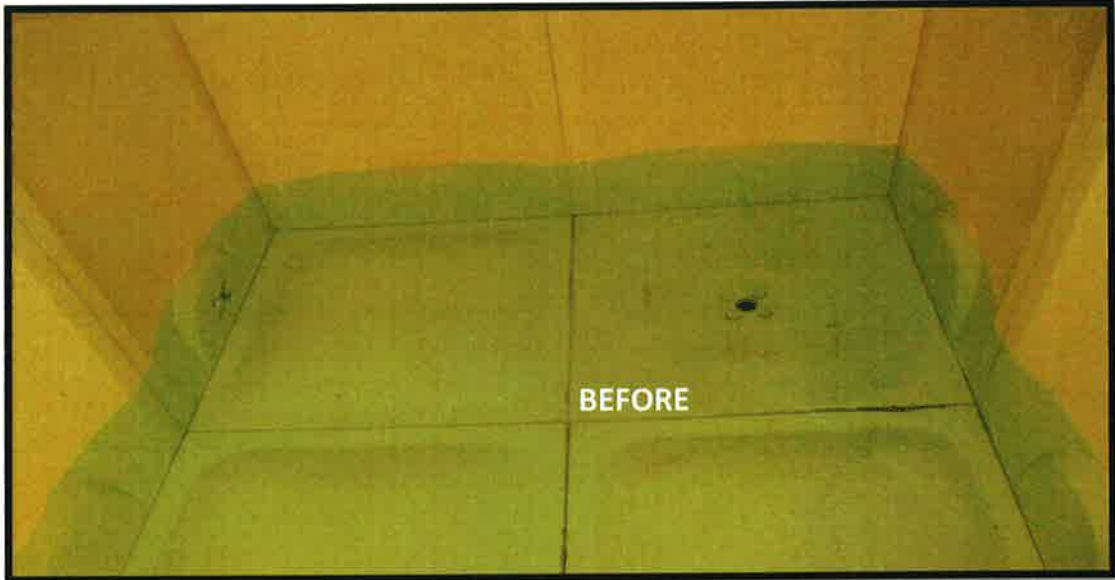
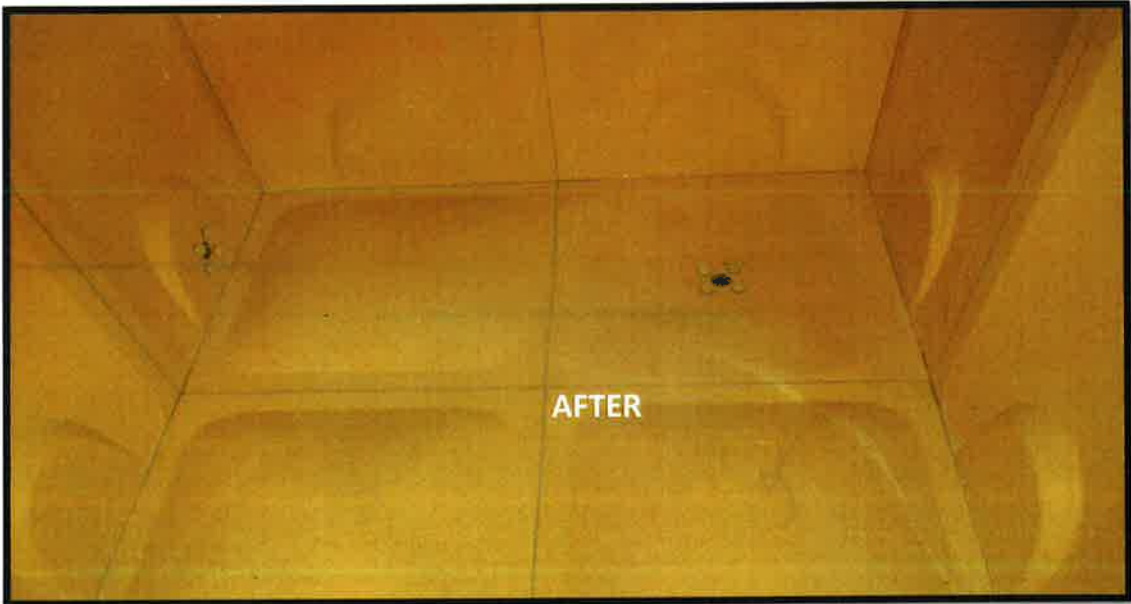
Roof Top Tank 3 - GRP

WATER TANK CLEANING & DISINFECTION

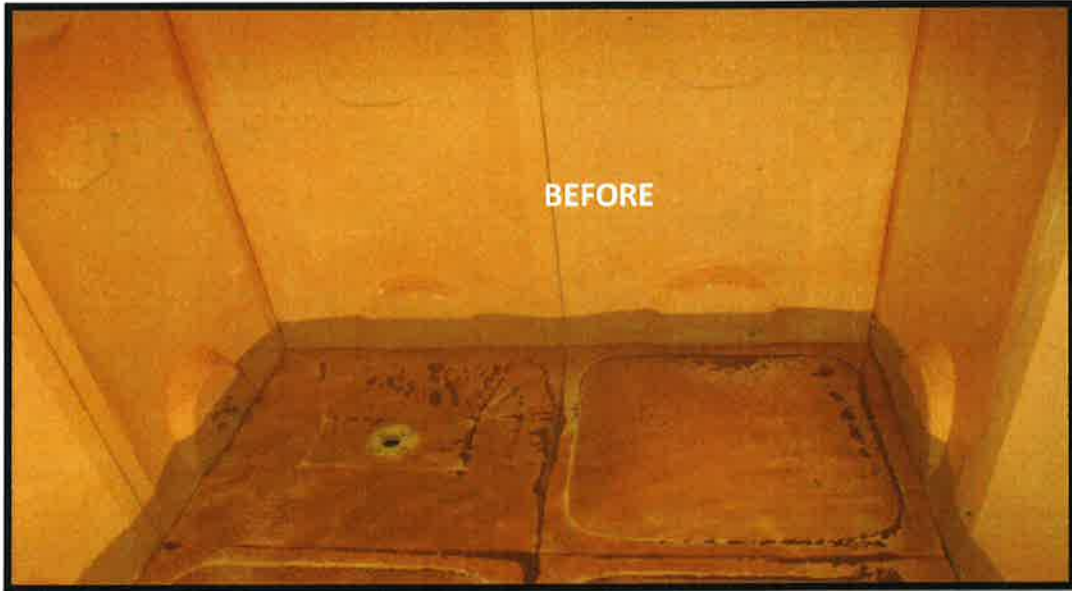
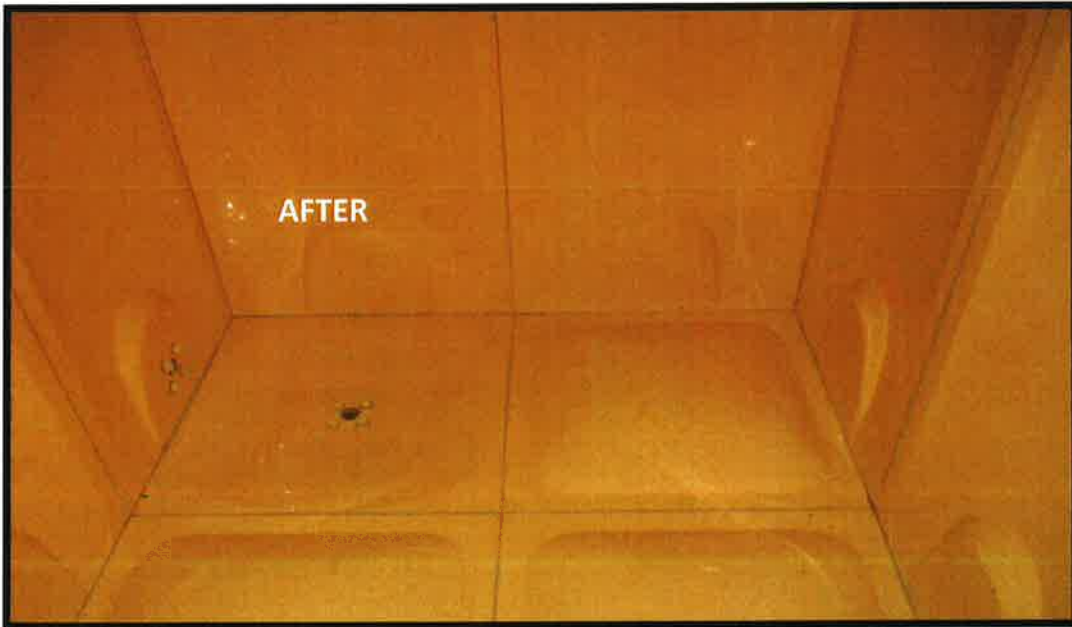
Roof Top Tank 4 - GRP

WATER TANK CLEANING & DISINFECTION

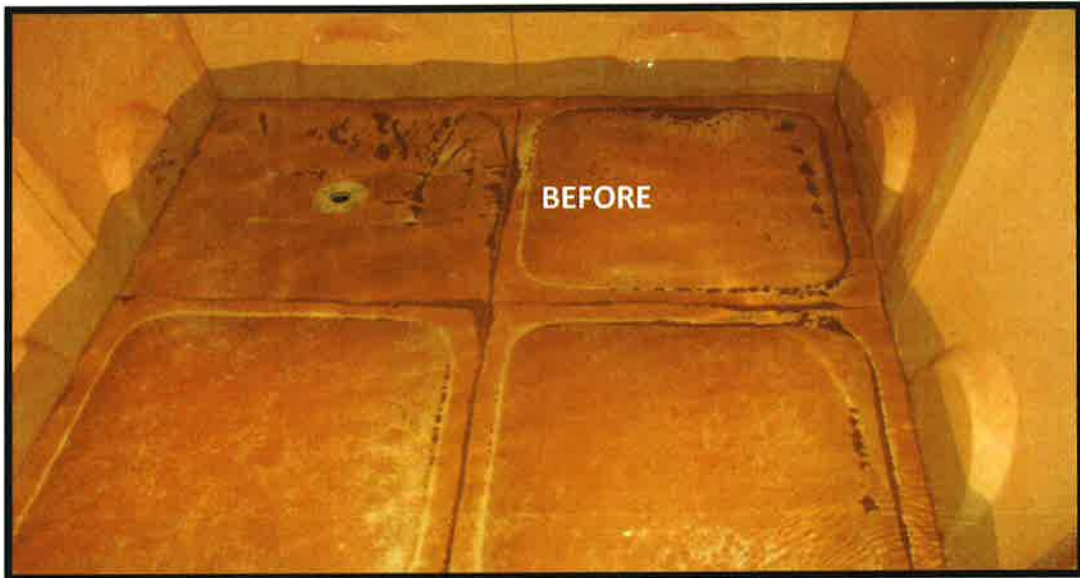
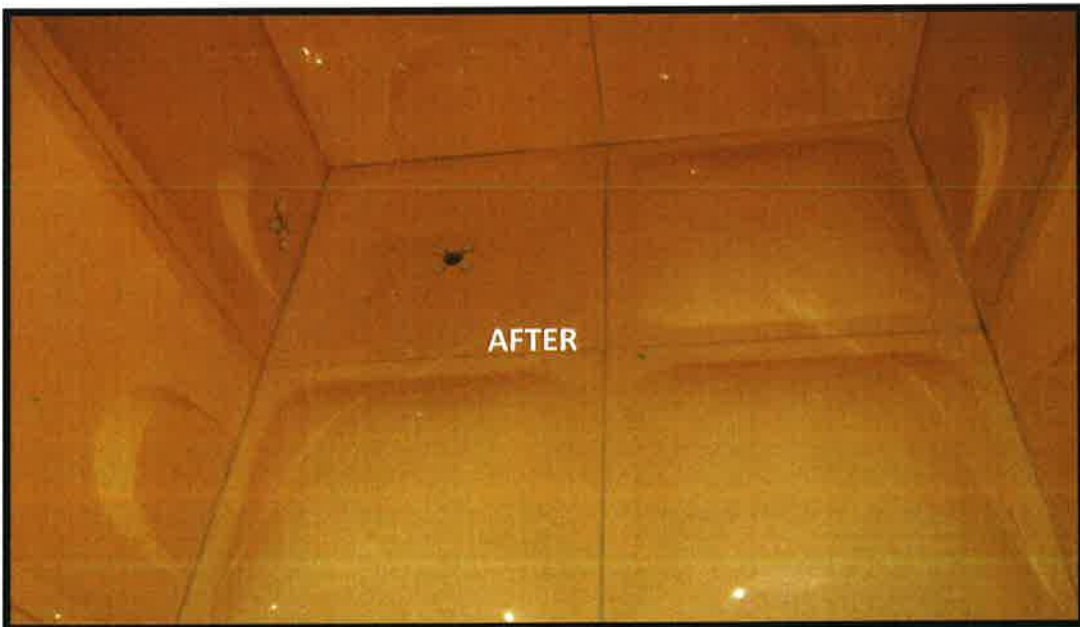
Roof Top Tank 4 - GRP

WATER TANK CLEANING & DISINFECTION
